Disability Resources

Electric Mobility Tricycle – Brake Redesign

Eleventh Annual School of Science, Engineering, and Health Symposium
May 2, 2014

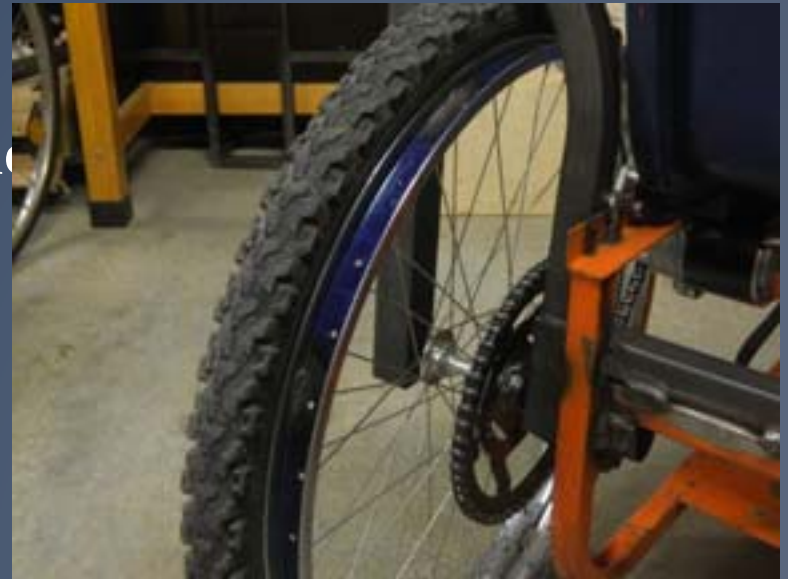
Double Rim Design

- Field data indicated buckling in the wheels.
- Double rim design increased strength and rigidity which solved the buckling problem.
- However, double rim design made brake problems worse

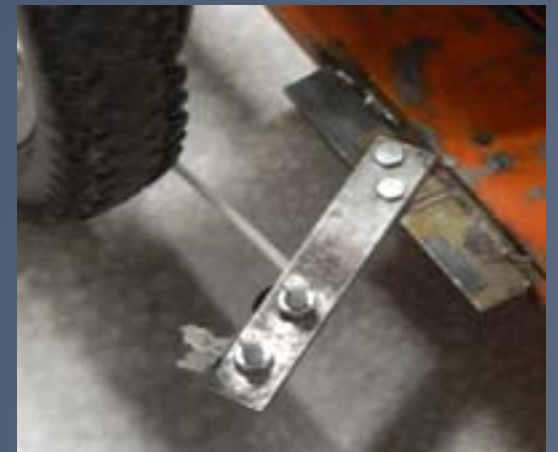
Band Brake Prototype

Throttle
Brake Lever
Brake Cable

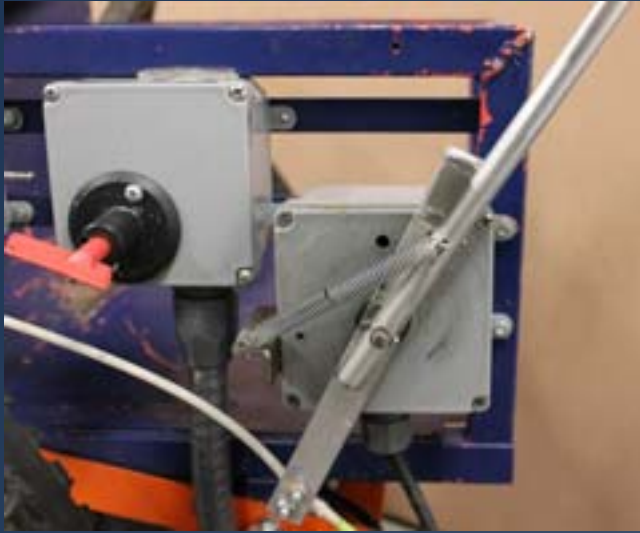
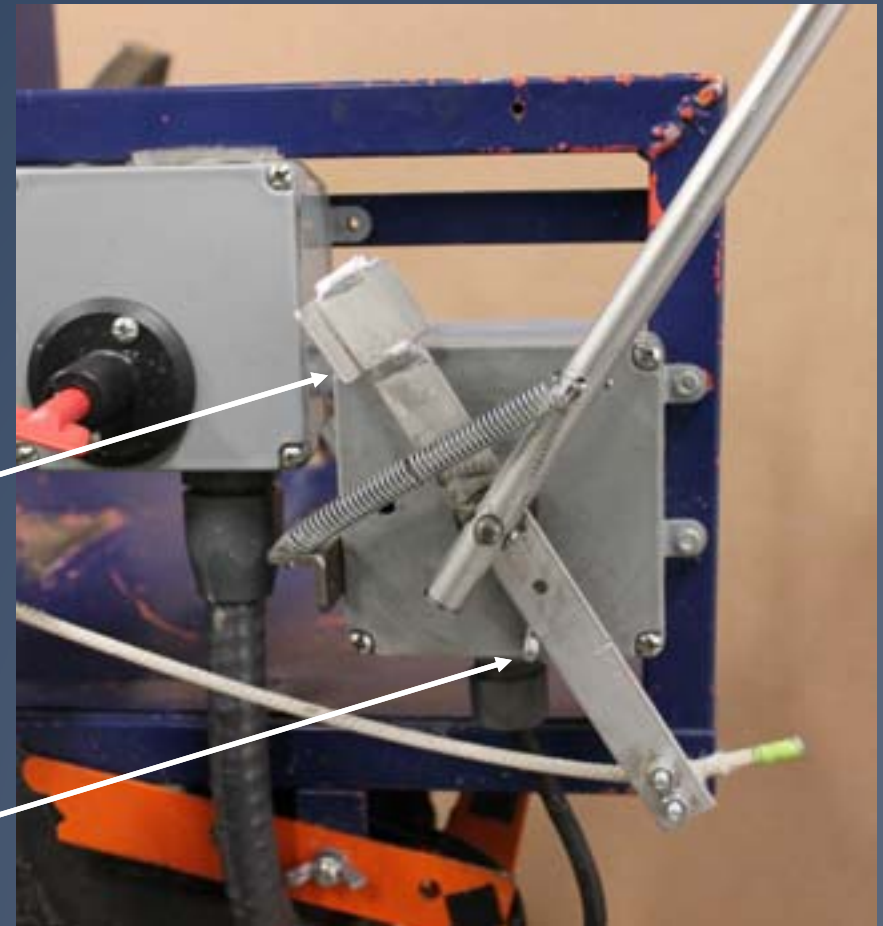
Solutions

- The brake lever does not rotate forward.

Pin

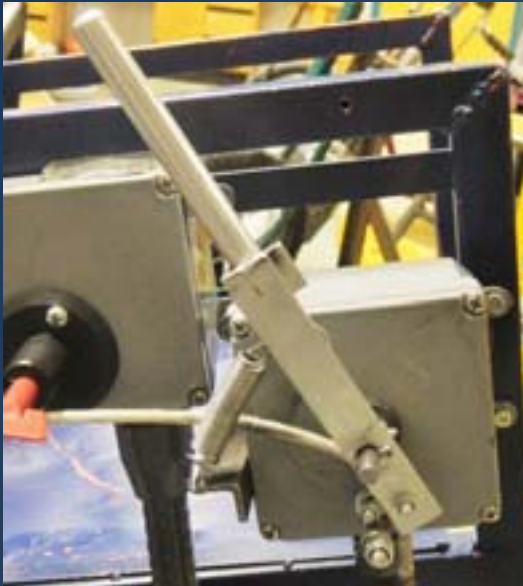
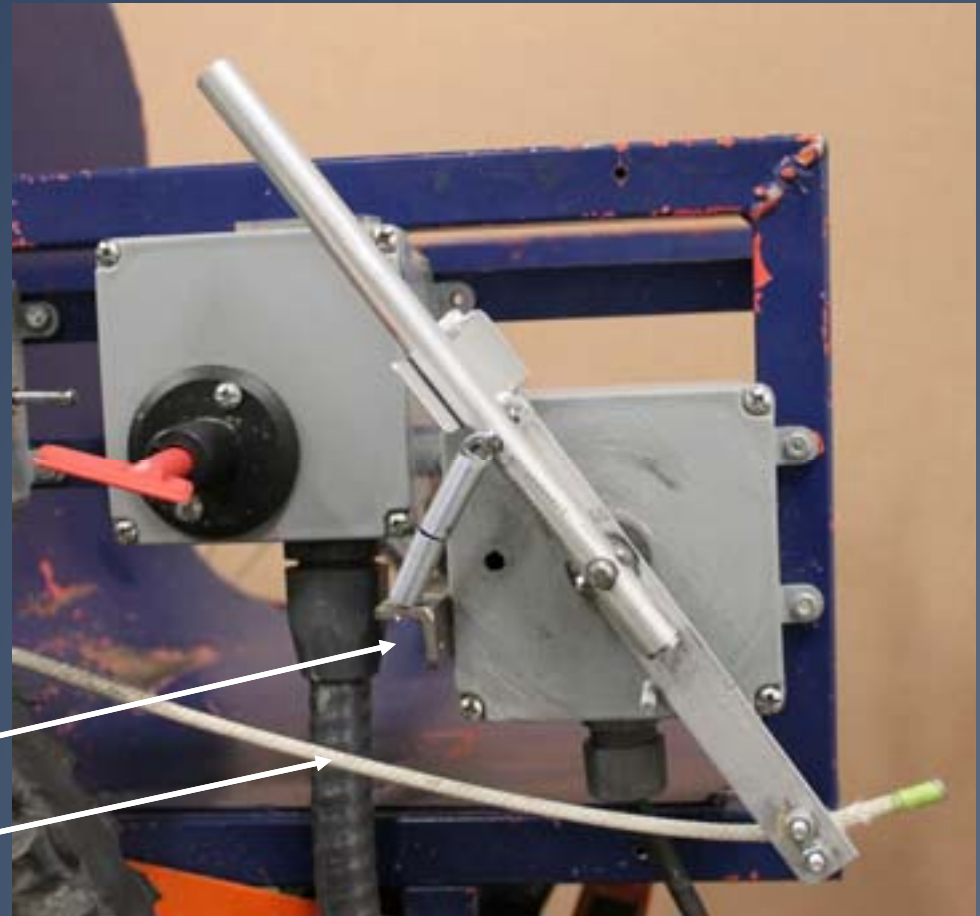
Solutions

- Spring bracket is avoided.

Bracket
Cable

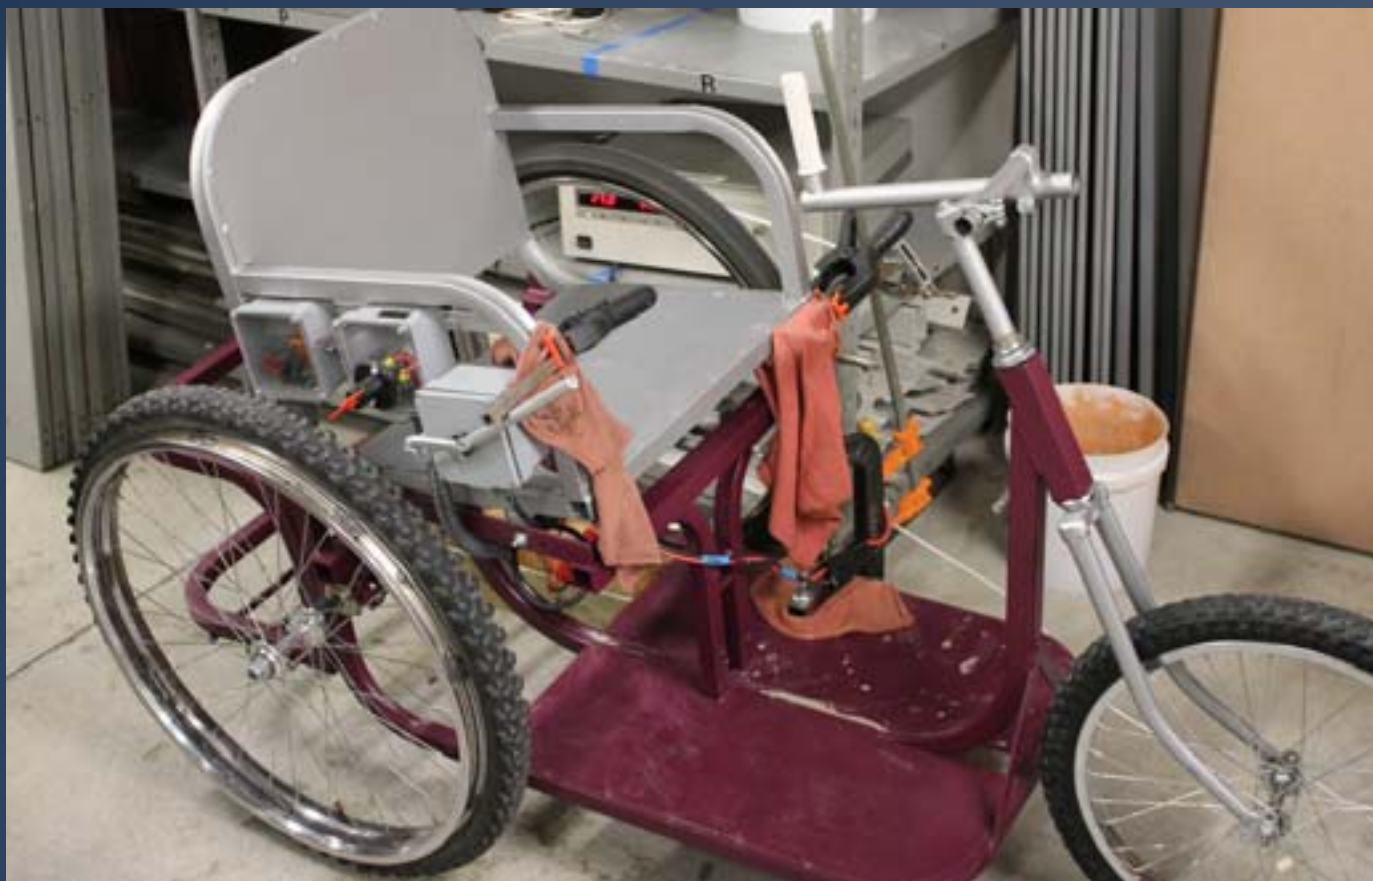
Apparatus

- Looked at durability under accelerated wearing conditions.
- Attached cable with 10 lbs of tension.
- Ran for 30-minute intervals at 10 mph (5 miles).
- Test ended once we reached 50 miles or cable broke
- Tested clean and dirty cables.
 - Dirty samples replicate conditions in Burkina Faso.

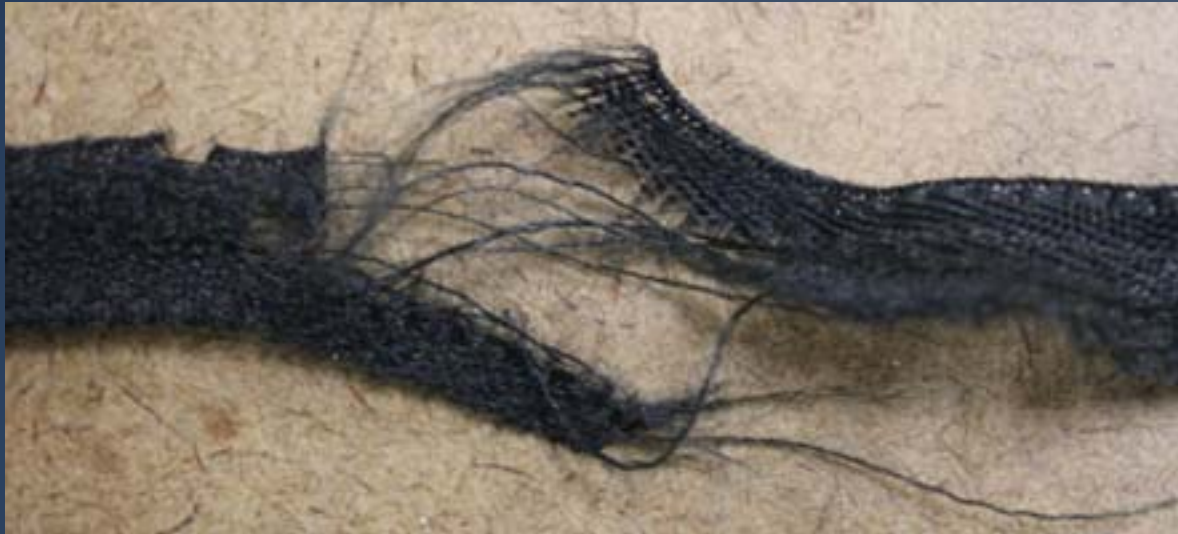
- Polyester – Both samples completed test.
- Nylon Strap
 - Failed after 33 miles.

- Reinforced Nylon – Both samples completed test.

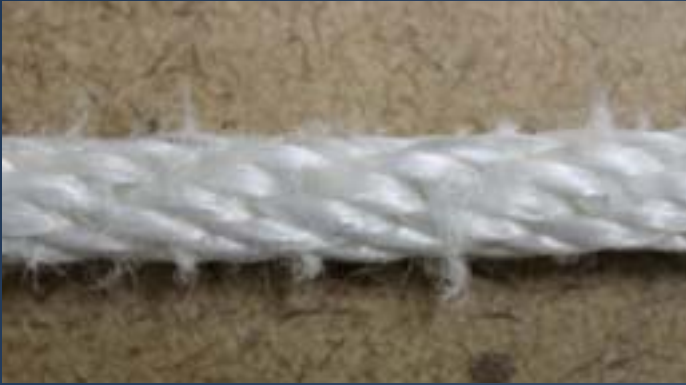
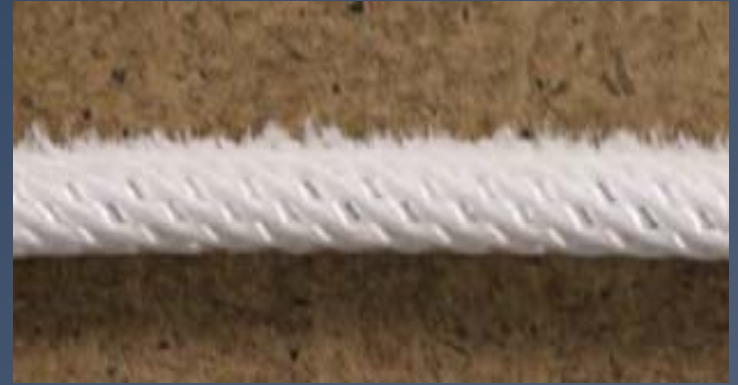
Clean

Polyeste
r

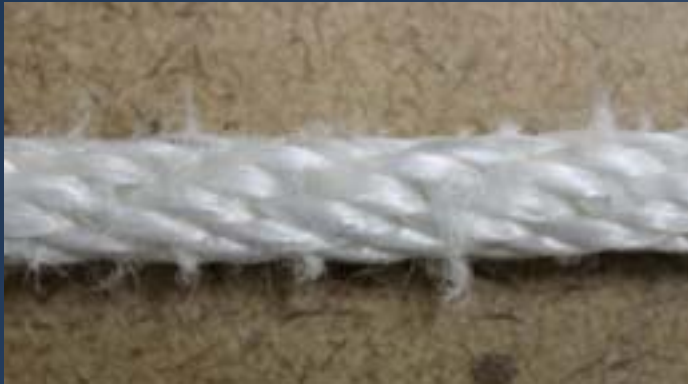
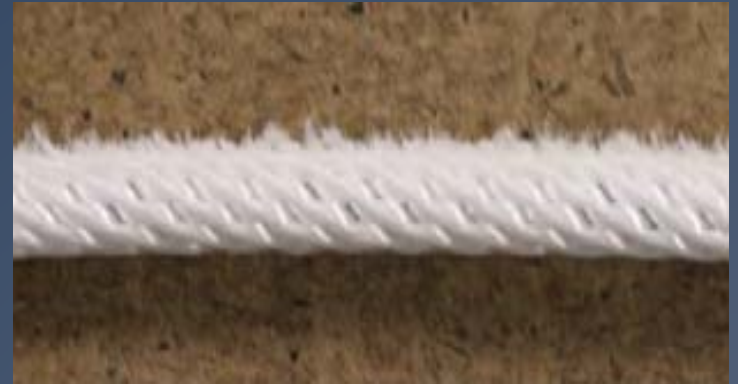
Clean

Polyester

Reinforced
Nylon

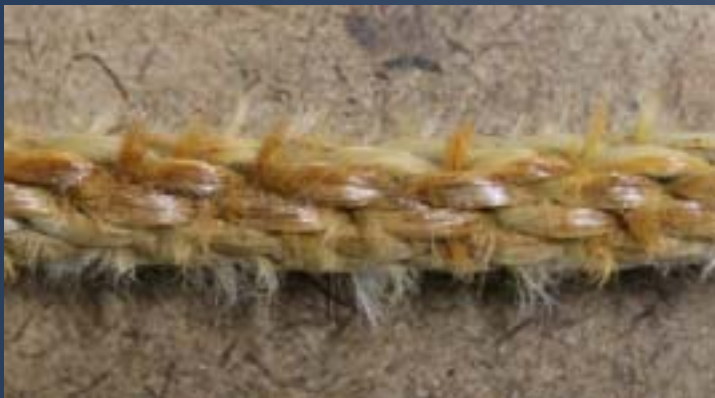
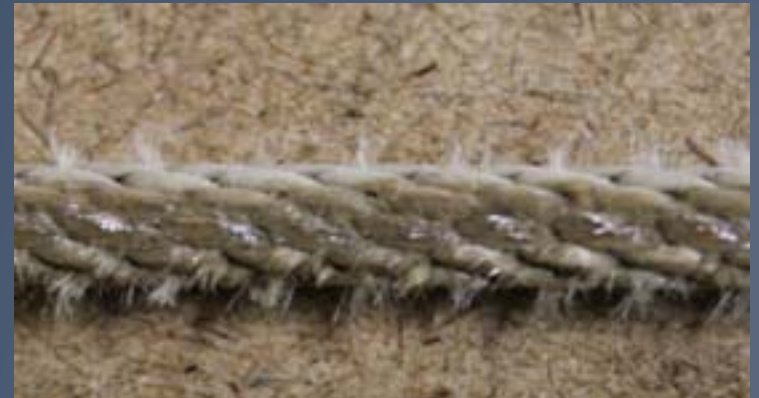
Dirty

Polyester

Reinforced
Nylon
